# Retrofit of an Operating Healthcare Facility

*Revamping your present laundry may obviate the need to build a new one, thereby saving you time and money*

By Gerard O'Neill

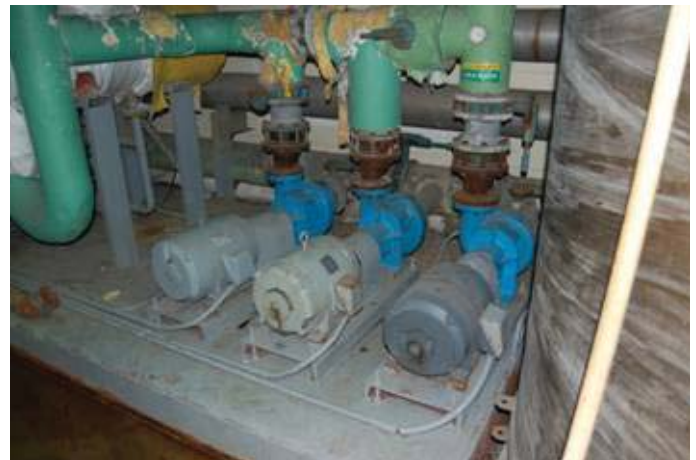
The existing plant's mechanical room was rife inefficiencies, including a boiler that operated at only 25-40% of full load, an inoperative wastewater heat recovery system and steam unit heaters that required complex maintenance.

- The online boiler operates at 25%-40% full load, depending on surge steam demands. The boilers have been adjusted so they do not cycle on or off, during low steam demand periods. A pair of 250 BHP boilers would ultimately be the “right sized” boilers for future steam demands.

- The wastewater heat recovery system is inoperable and at current water heating load, approximately 39% of the energy used for water heating load is not being recovered properly.

- The delivery of water can be satisfied with 15 HP pumps, vs. 25 HP pumps. The electrical difference is for operation of the two different pumps is that the consumption of the larger pumps is approximately 58% more than is required.

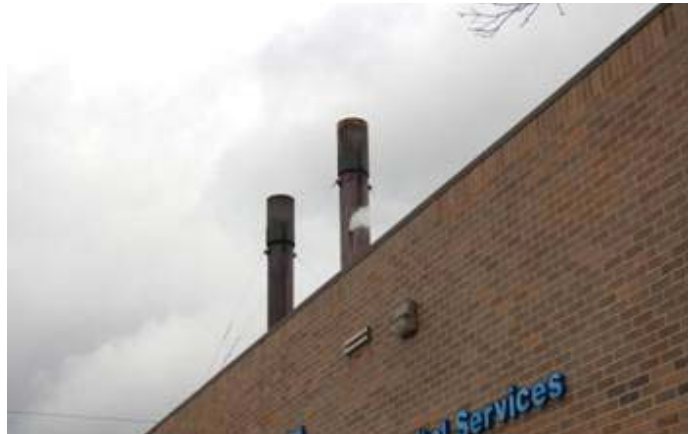
*A steady loss of flash steam (see stack above) from the boiler feed tank posed another costly problem for plant operators.*

- The fiberglass cold water storage tank is leaking.
- The cold water, well surge tank in the boiler room has been patched numerous times and eventually will need to be replaced.
- There is a constant stream of flash steam leaving the boiler feed tank vent.
- Removal of the existing wastewater heat-recovery system and process water system to install a properly sized system is highly recommended.
- Monitoring equipment such as gauges and thermometers are missing and inoperable from the water system equipment.
- About 15 feet of insulation is missing off a 3-inch steam line. With the mechanical room air temperature acclimating to about 130°F in the overhead where the steam line is located, this loss is equivalent to approximately 10,110 Btu/hr.

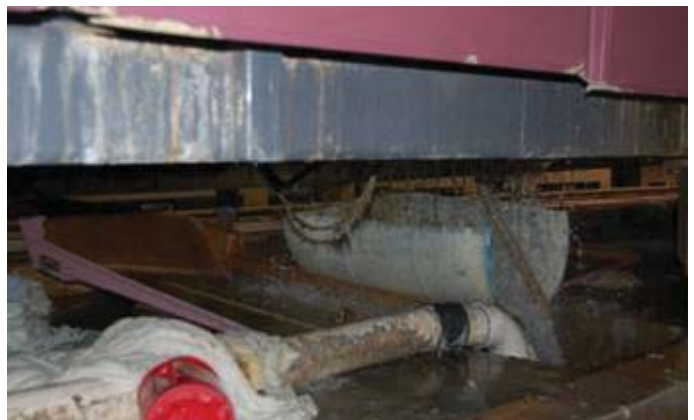
*Water leaking from the seals under one of the tunnel washers cost the laundry operator 15-25 gpm from the worst seal.*

- Visual inspection of building unit heaters shows that the heaters are extremely soiled with lint and heat transfer surfaces are impacted.
- No. 2 batch tunnel washer leaks water from the seals, resulting in approximately 15 to 25 gpm flows from the worst seal. This range of water pouring out of the tunnel washer amounts to about 8% of the water heating requirement or approximately 482 lbs. of steam per hour. This steaming requirement could maintain another flatwork ironer.

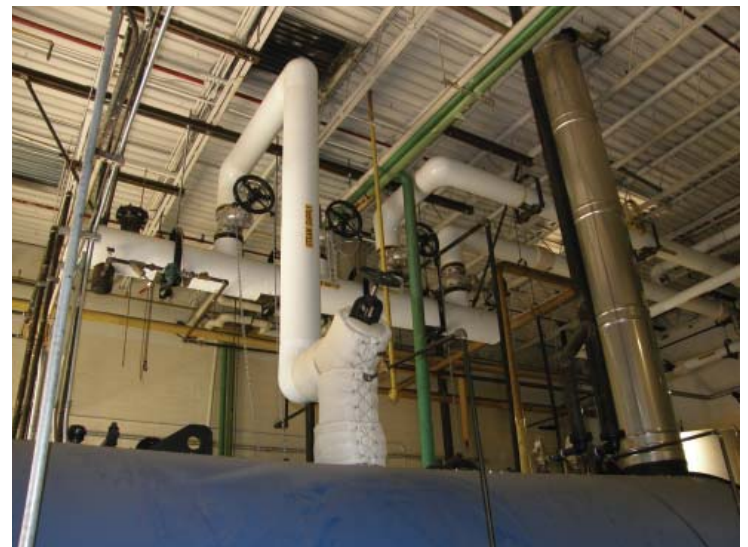
*A view of the new boiler room infrastructure, which includes a new process water system with water tanks, a pump package and a plate-and-frame heat exchanger.*

- The process water system was completely demolished, redesigned and replaced with a new process water system including water tanks, pump package, plate & frame heat exchanger, condensate heat exchanger, etc., essentially pre-heating the incoming water from 60°F to 130°F for *free!*

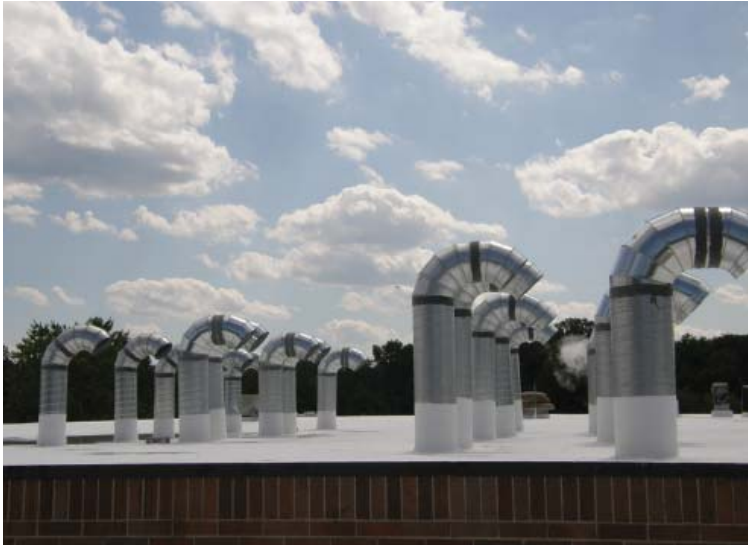
A view of a new intake and exhaust duct system for dryers in the plant

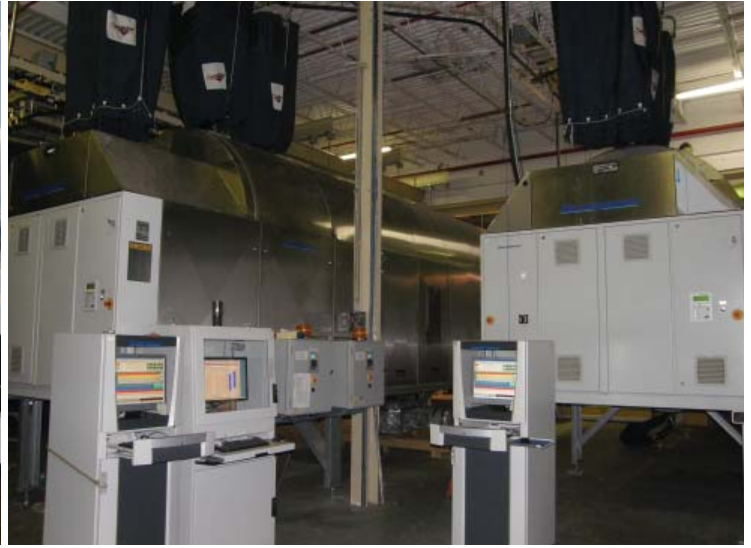
A look at the plant's two new Kannegiesser tunnel washers with an automated loading system that has largely eliminated the use of carts on the wash floor.

- (2) *New* Kannegiesser 75kg tunnel systems were installed in the bottom half of the soil room with the dryers installed in the “*old*” conventional washroom area.
